# John H. Overton Upstream Lock Guard Wall Prototype Experiments

by Frank M. Neilson

Final report

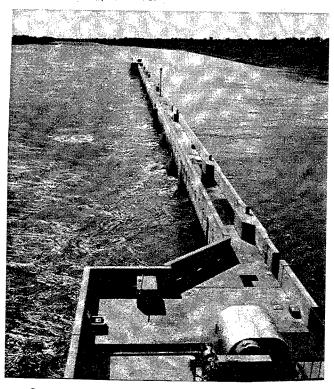
Figure 4. Upstream guard wall at John H. Overton Lock

Small (estimated as 2 to 3 ft in diameter) but intense vortices occur intermittently in the navigation channel over port number 12.5 and, to a lesser extent, over port 12. Severe surface turbulence existed on the spillway side over ports 12.5 to 10. Smoother flow existed on either side upstream from these ports.

a. Guard wall, 24 May 1991. View looking upstream; the turbulence along the spillway side is most severe for ports 10-12.5

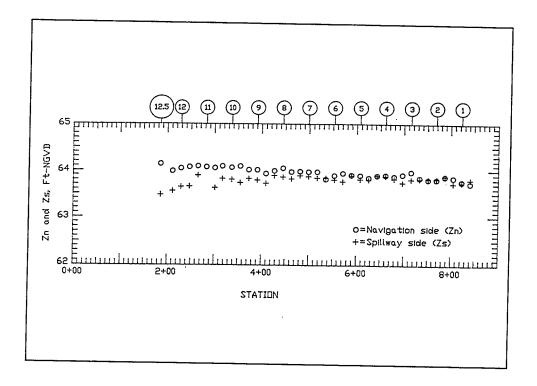
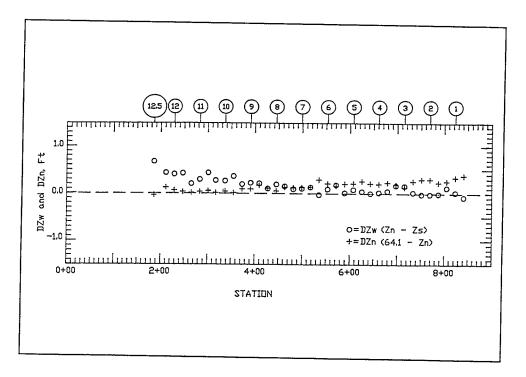
Figure 8. Water-surface measurements (29 Jan 1991), Upper pool el. = 64.0 ft NGVD, River flow = 85,000 cfs

- a. Tow drift. The upstream drift of tows from the lock chamber results from a water surface that slopes downwards from the lock chamber into the approach area. The slope continues over the total length of wall, Figures 8-10, and is most severe between station 1+75 and about station 4+00. A tow will drift in an upstream direction until drag due to increasing near-surface velocities, Figures 18 and 19, and mechanical friction between the barges and the wall cause the motion to cease.

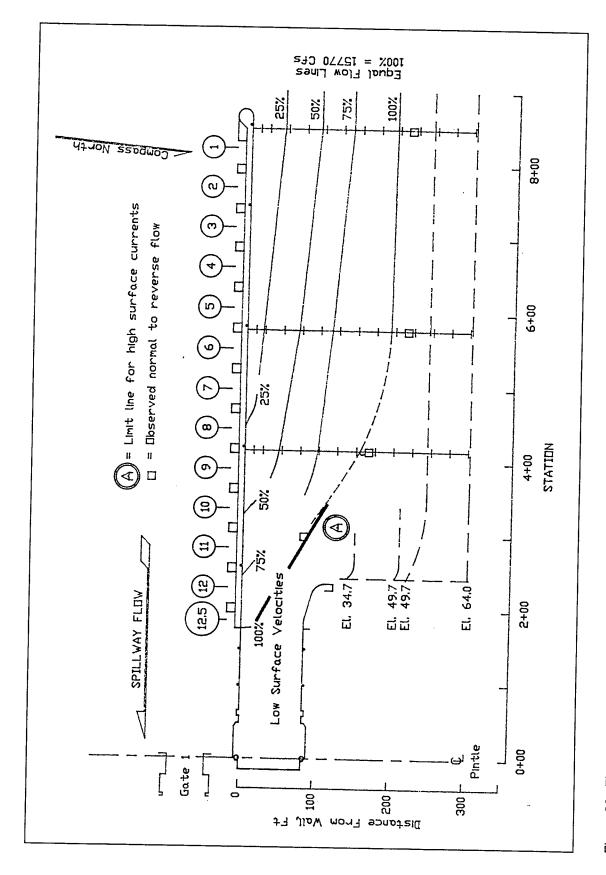
Figure 20. Flow distribution in the approach channel. 29 Jan 1991 experiments (Q = 85,000 cfs)

- b. Tow binding along the guard wall. The slope of the water surface over the approach area is indicated by the flow lines shown in Figures 20 and 21. The highest water-surface elevations are within the low velocity region landward of the 100% flow line. The lowest elevations are within the high-velocity region near the guard wall. The gravity force resulting from this slope, and the drag force resulting from velocity, have components that are directed toward the wall. For a 600-ft long tow, these forces are expected to be greatest when the tow is positioned between stations 1+75 and 7+75 based on the flow lines shown in Figures 20 and 21. The position for greatest normal force is independent of direction of tow movement. However, the velocity and slope parallel to the wall, which affect the power needed to offset friction between the tow and the wall, will affect the location at which binding occurs.

- c. Upbound tows. The upbound tow, to avoid binding along the guard wall, probably should be oriented with the bow off the wall and aligned with the approach flow. The operation needs to be carried out without having the stern impact on the miter gate. For lower flows with modest forces, Figure 20 for example, the operation is probably not an unusual

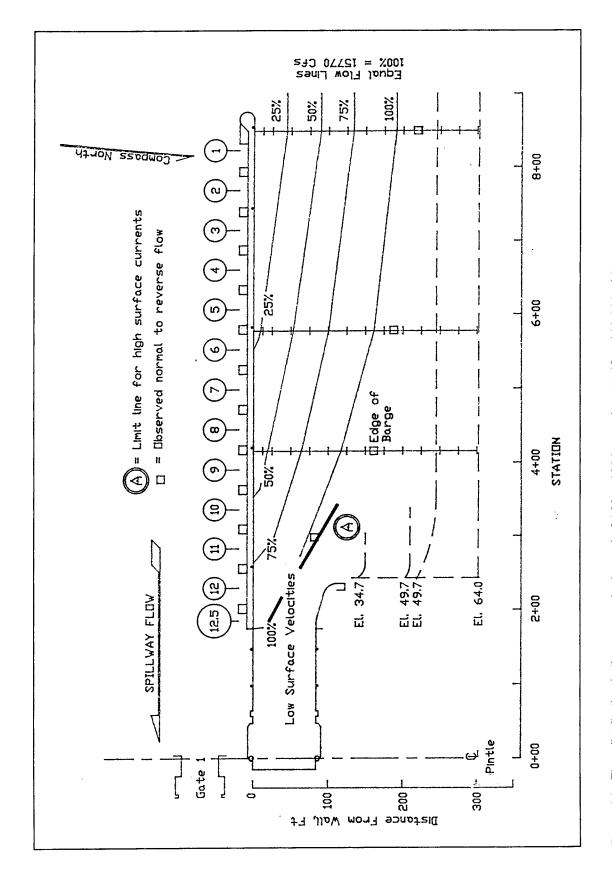
Figure 21. Flow distribution in the approach channel. 24 May 1991 experiments (Q = 116,000 cfs)

- exit condition. For higher flows with severe forces, Figure 21 for example, the operation is more unusual in that an inadequate operation apparently results in binding whereas an excessive operation forces the tow into the left (descending) bank. More precise suggestions for operation require field assessments so that towboat power and steering mechanisms can be considered.

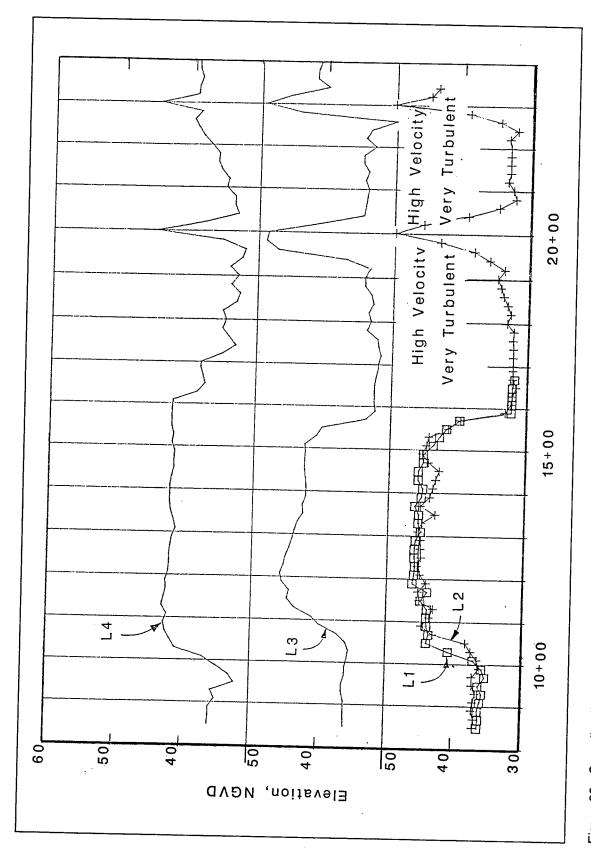
Figure 22. Sounding lines (24 May 1991)

High surface currents apparently occur immediately downstream of each of the two dikes as suggested by the profiles of the dikes shown in Figure 22, lines L3 and L4, as well as by on-site visual observations. Severe turbulence is suggested by interference on the sounding record, commonly associated with air entraining flow, as well as by on-site visual observations.
